F-1-195
Thomas Sinn Farmstead
Adamstown vicinity
Private

F-1-195
Thomas Sinn Farmstead
Adamstown
Frederick County

State Historic Sites Inventory Form

historic Thomas Sinn Farmstead

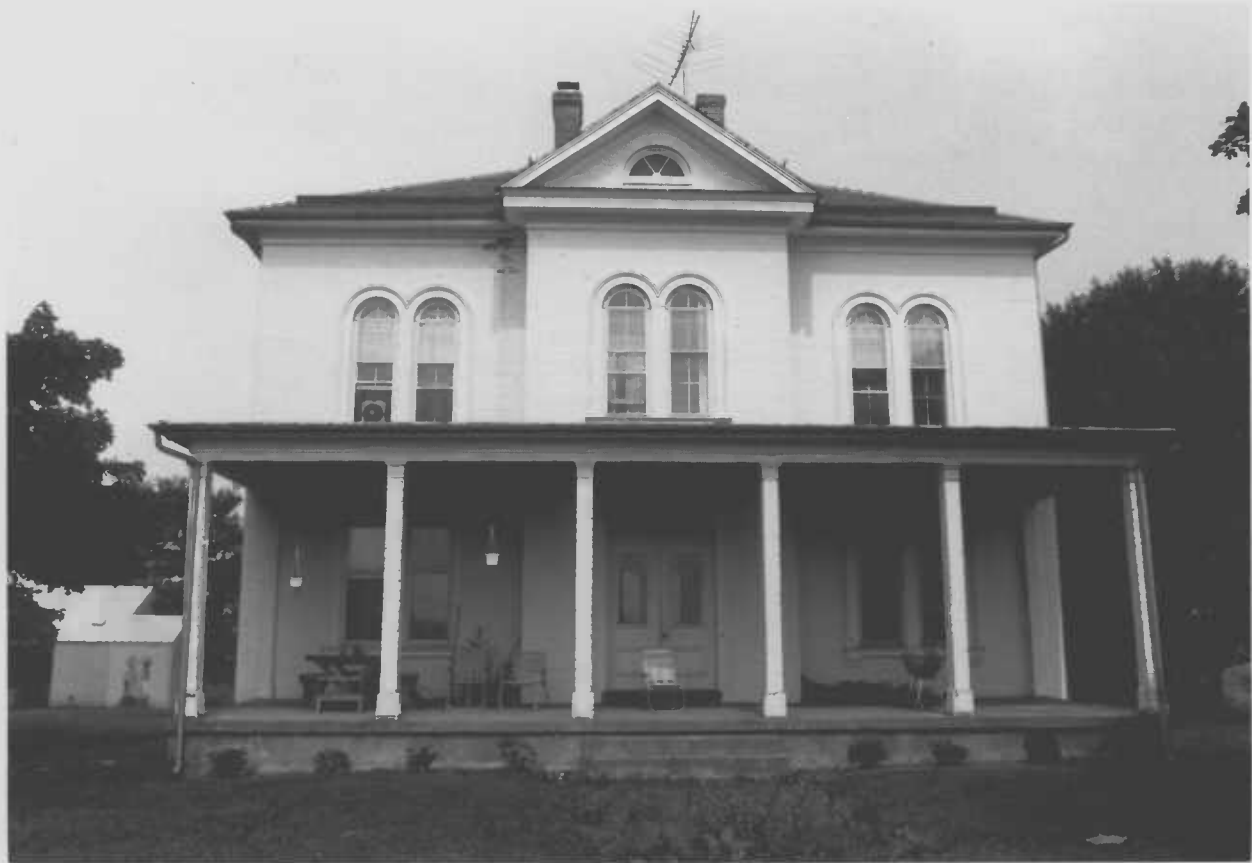
1/6

East elevation

The main dwelling is a large, two-story brick mansion with a two-story rear wing extending from the northwest corner. The low-pitched hipped slate roof has a central gable over the projecting center bay of the east elevation and extended eaves above the rather plain cornice. Large houses on other properties in the area have evidence of observation platforms or widows' walks on the roofs. The Sinn House has four central chimneys; however, it seems likely that the house may also have had a similar feature. A central element such as a tower or railed platform is a characteristic of the Italianate style. The first story has a full-width veranda with square posts on a concrete deck. The porch probably had more decoration in the form of brackets and trim in its original form, based on the appearance of porches of similar dated houses in the vicinity. The walls are painted white. The windows on the east elevation are paired on both stories, with round arches and molded hoods on the second story. The sash is 4/4. The first story windows have flat arches with 4/4 sash. The central gable has a full pediment with a centered semi-circular window lighting the attic. The center entrance has double, arched panel doors with glazed upper sections and a four-light transom. The south elevation probably originally had a full-width porch as well, because the three bays on this side have jib windows on the outer bays. Although the lower panels have been sealed and covered with plain wood panels, the flanking louvred shutters are the full height of the openings. Each window on this elevation has a molded lintel and 6/6 sash. The north elevation also has three bays, with evidence of later brick infill below the center opening, suggesting that a doorway was at this location in the original design. The two story rear wing has a slate roof and three bays on both the north and south elevations. The south side also has a two-story open porch with plain balustrades on both levels. The sash is 6/6. A two-story shed roofed single bay brick addition is attached to the west end. This addition is clearly a later construction, but its date is unknown. A boarded doorway is on the north elevation and a small two-story porch on the south side has a frame-enclosed, extended first level. The current tenant of the main dwelling, Mrs. Hammond, related a local tradition that this addition was built for black servants of the owners, but the date is unknown.

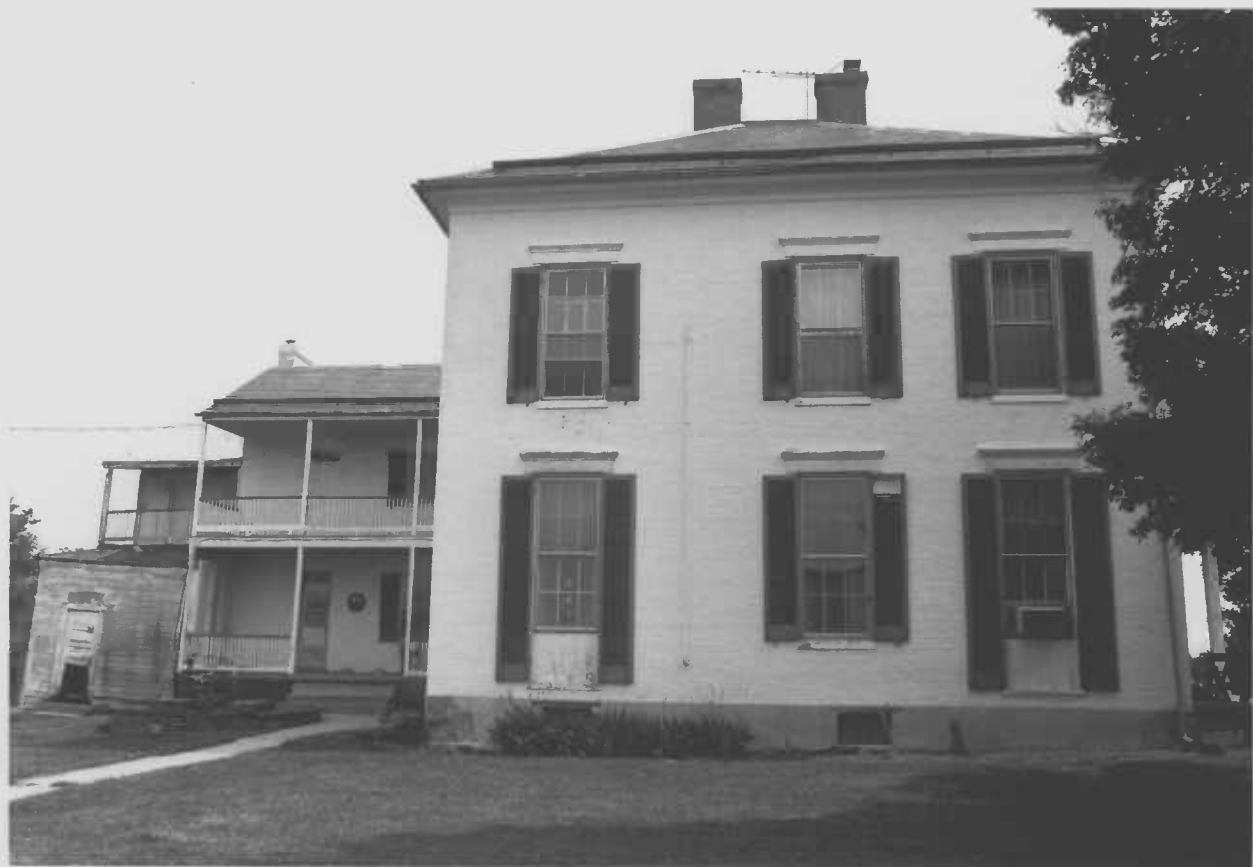
2/6

South elevation

The Thomas Sinn Farmstead is significant in architecture for the Italianate style of the main dwelling, a large two-story brick house with paired arched windows and a projecting center bay with a full pediment and semi-circular window. Jib windows on the south elevation hint at a missing porch on that side, while the full-width porch on the east elevation appears to be a replacement of a more decorative original porch. The hipped slate roof probably had a central tower, cupola, or observation platform, but it has been removed. The interior has 14-foot ceilings on the first story. The remaining contributing outbuildings are a frame bank barn, a wagon shed/corn crib, a chicken house, and a tenant house. All except the tenant house date from the period 1875 to 1910. The tenant house, which was not available for documentation in this survey, may be a much older house which was mentioned in Grove's History of Carrollton Manor as a 1-1/2 story house occupied by elderly Thomas brothers around the Civil War period.

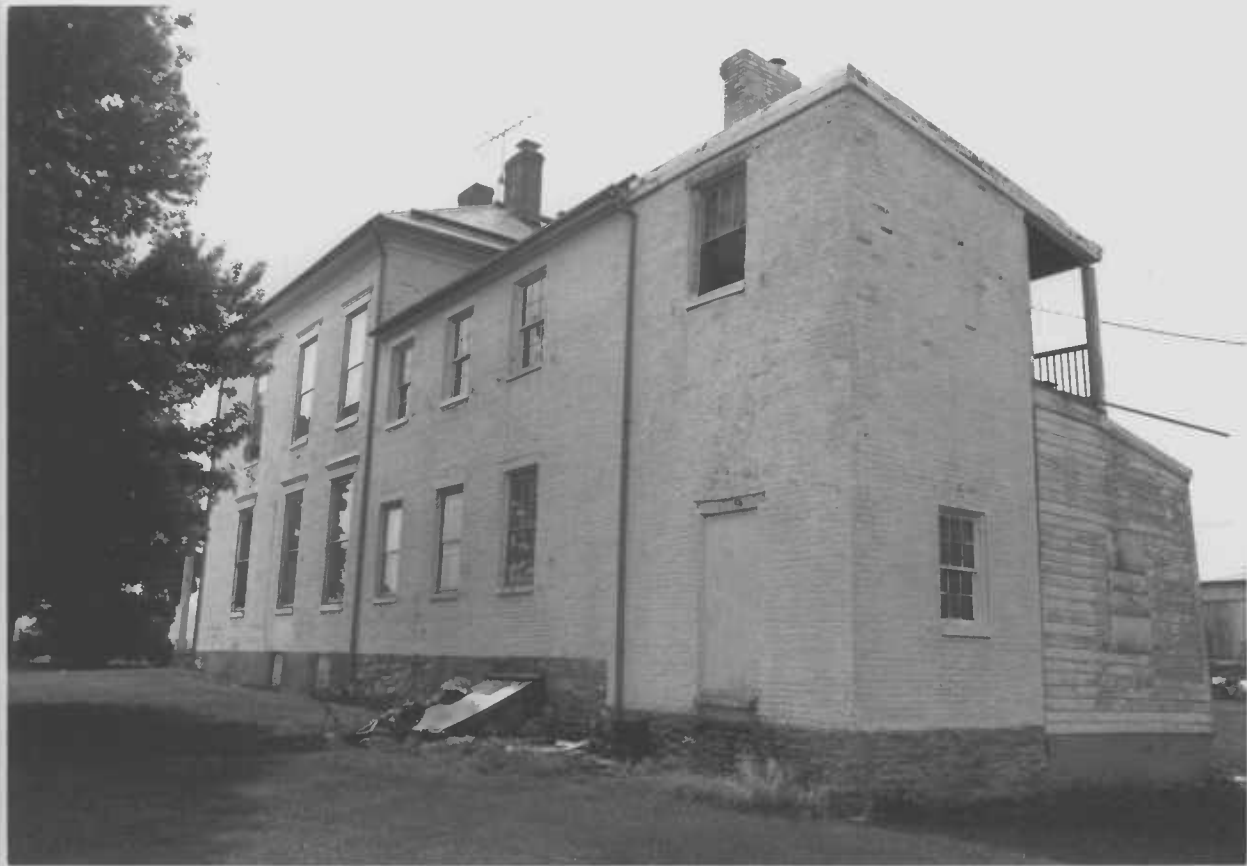
3/6

Northwest corner view

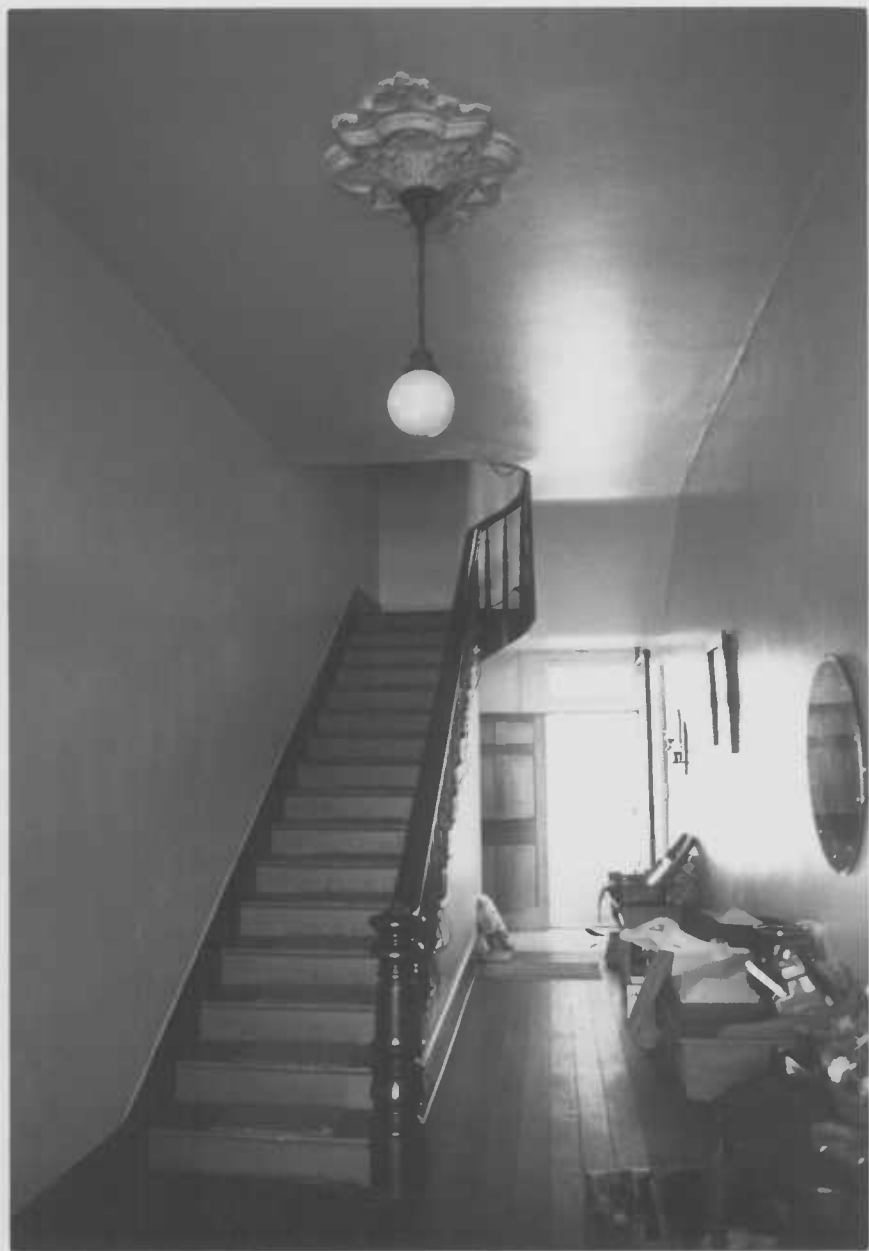
4/6

Central stair hall

The interior of the house has 14-foot ceiling heights on the first story. The center hall has painted plaster walls and a central molded plaster medallion with an early 20th century hanging globe light. The turned newel post and stair railing are dark-stained, possibly mahogany. Scroll-sawn closers ornament the stairway. The door trim is pine and the doors have six panels. In the rear wing second story, the trim is grained. Mantelpieces in the main floor are rather simple molded wood and the floors appear to be the original hardwood boards.

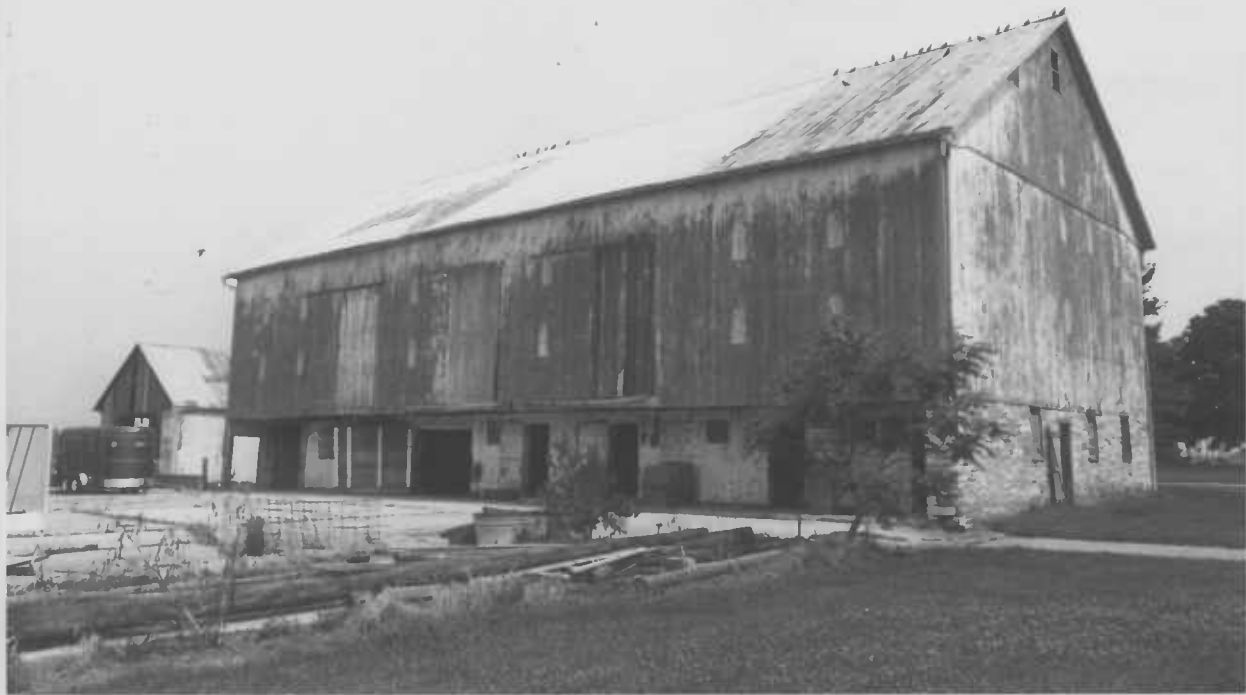
5/6

Bank barn, Southeast corner view

Bank barn: The frame bank barn is located south of the house has weathered, white-painted tongue-and-groove siding with painted arched "vents" which were apparently painted over with whitewash and revealed when weathering took place. The tongue-and-groove siding, the vertical board enclosed stall level on the south, and the generally more coursed stone foundation strongly suggest that the barn was built in the late 19th century. A non-contributing concrete silo stands next to the ramp on the north elevation. The property also contains a non-contributing concrete block dairy barn and milk house.

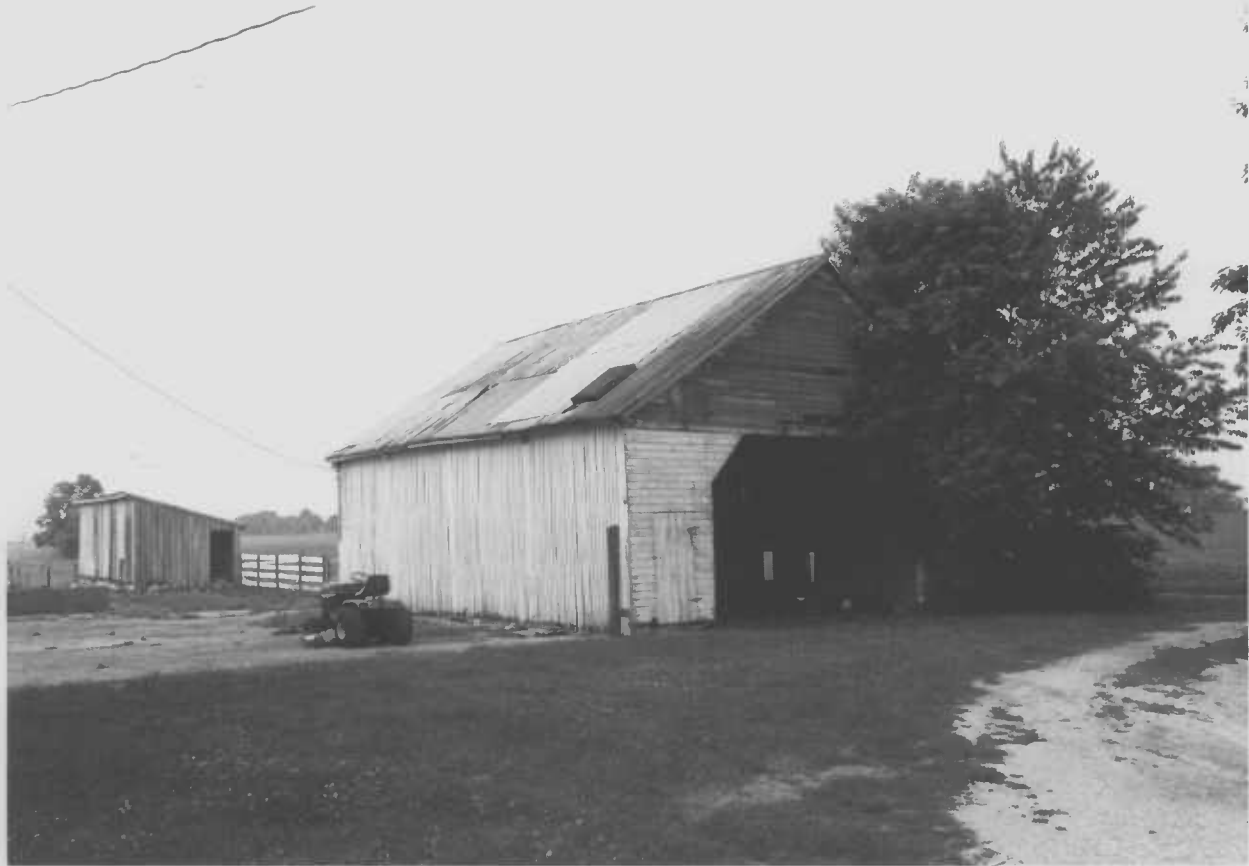
6/6

Wagon shed/corn crib, northeast corner view

Wagon shed/corn crib: The frame wagon shed/corn crib is located west of the bank barn. The north and south elevations have german siding which is rather deteriorated. The east and west corn cribs have vertical board siding. The roof is corrugated metal and is also deteriorated. The date of the wagon shed is probably about 1900.
